**A PRELIMINARY GEOTECHNICAL AND
HYDROGEOLOGICAL REPORT FOR THE PROPOSED
MALELANE HOTEL DEVELOPMENT, KRUGER PARK,
MPUMALANGA**

**Preliminary geotechnical and hydrogeological findings based on
desk study and visual observations**

February 2011

WH10072 – MALELANE HOTEL KRUGER PARK

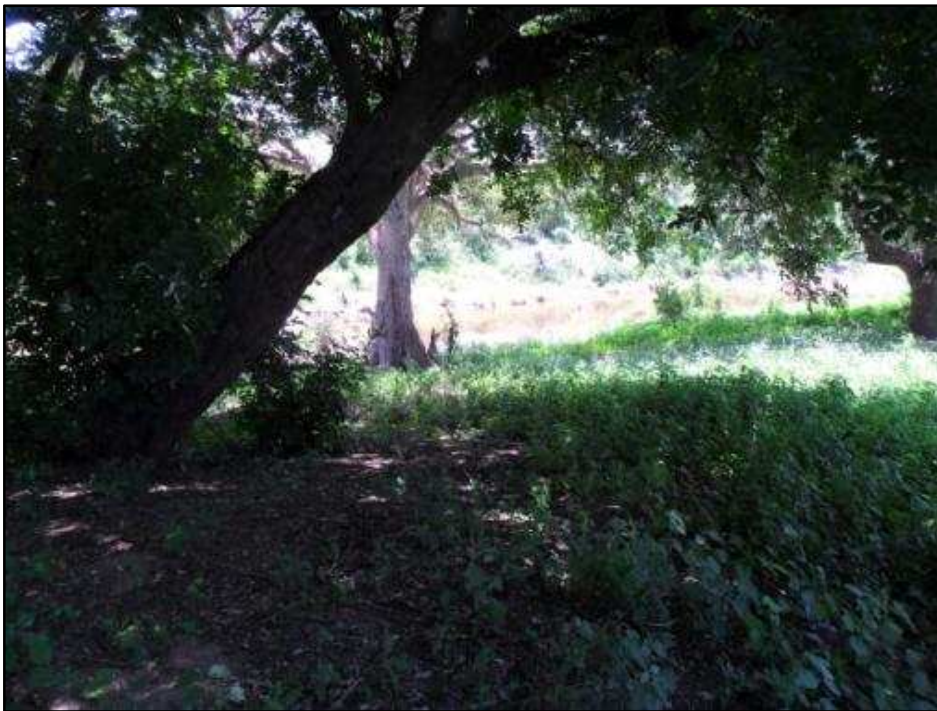
The site is predominantly covered with tall grass and shrubs, with a number of large riparian trees (including Natal Mahogany, Sausage Tree, Jackal Berry and Ficus).

PHOTOGRAPH 1: EXAMPLE OF LARGE TREES ON SITE 1

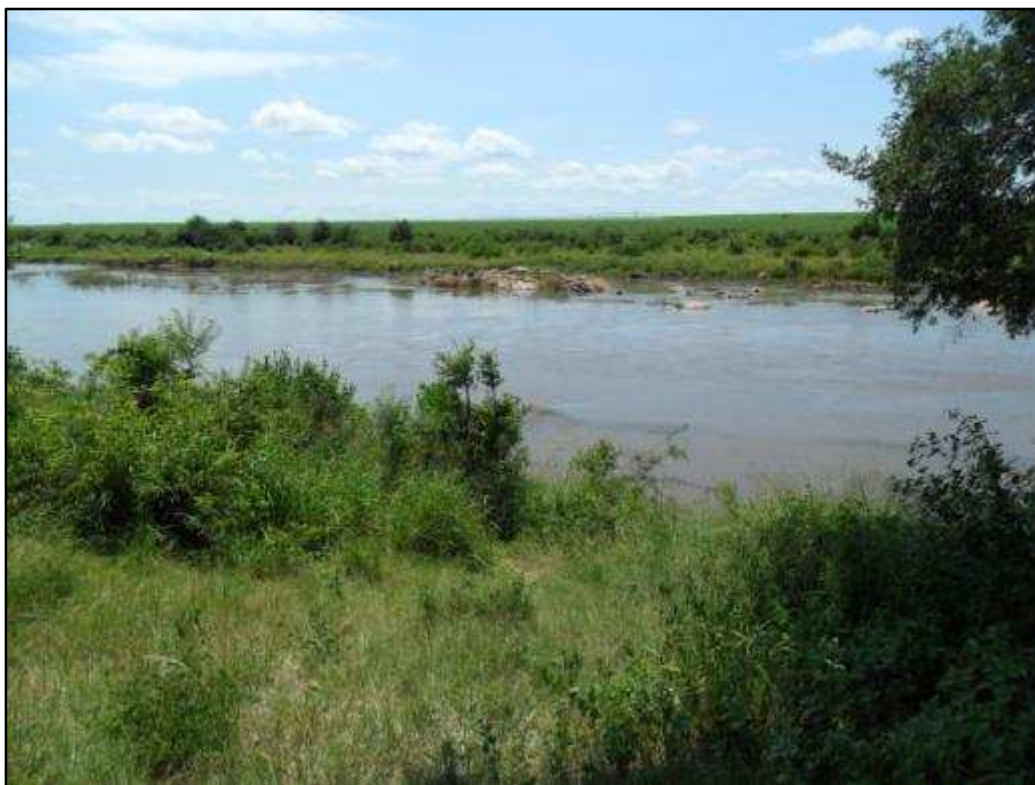
The seasonal Matjulu River runs from west to east along the northern boundary of the site, draining towards the large perennial Crocodile River which forms the eastern boundary of the site. It is expected that rainwater will mainly drain as surface flow or sheetwash and percolate through the upper, more permeable topsoil and colluvium/alluvium horizons to drain with the angle of slope towards the lower slopes and in the direction of the Crocodile River.

PHOTOGRAPH 2: PERENNIAL CROCODILE RIVER TO THE EAST OF SITE 1

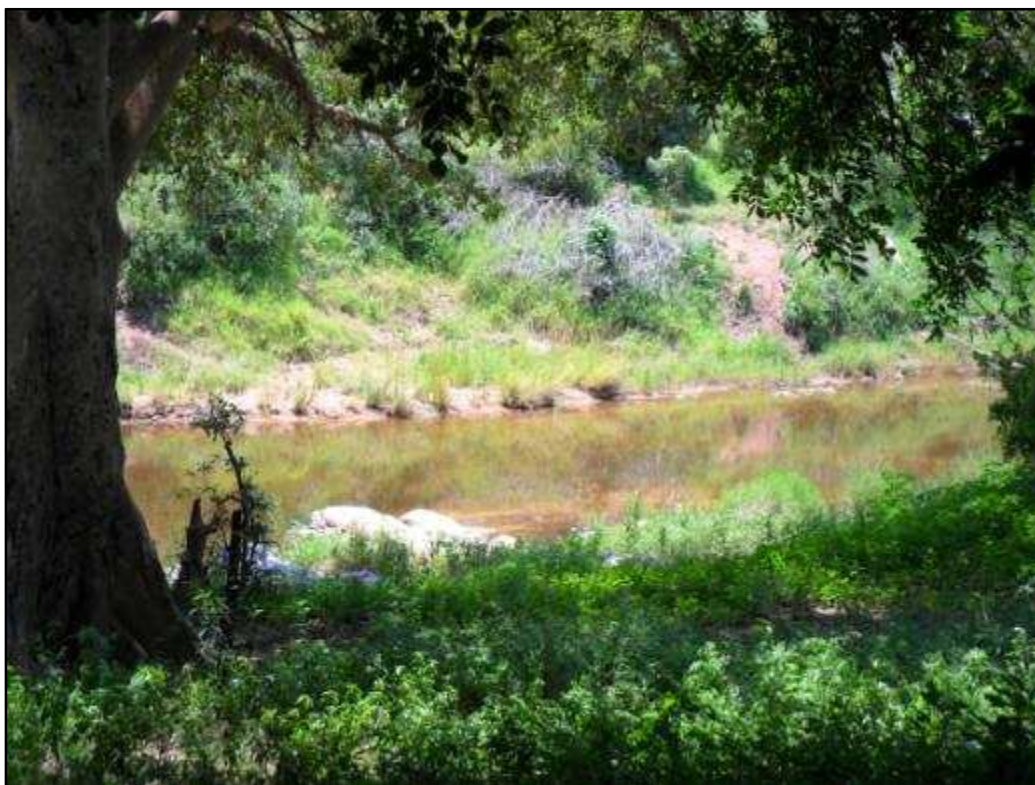
PHOTOGRAPH 3: SEASONAL MATJULU RIVER TO THE NORTH OF SITE 1

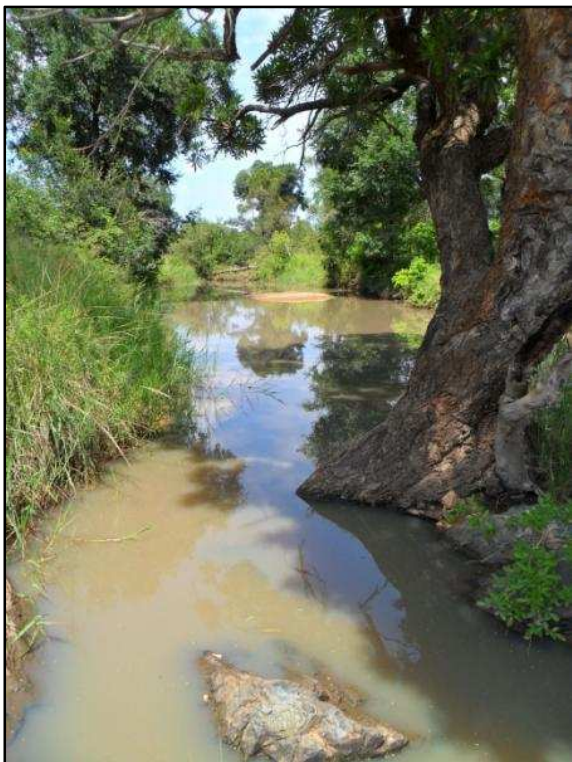
The seasonal Timfene River runs from west to east along the northern boundary of the site, draining towards the large perennial Crocodile River which forms the eastern boundary of the site. It is expected that rainwater will mainly drain as surface flow or sheetwash and percolate through the upper, more permeable topsoil and colluvium/alluvium horizons to drain with the angle of slope towards the lower slopes and in the direction of the Crocodile River.

PHOTOGRAPH 4: SEASONAL TIMFENE RIVER TO THE NORTH OF SITE 2

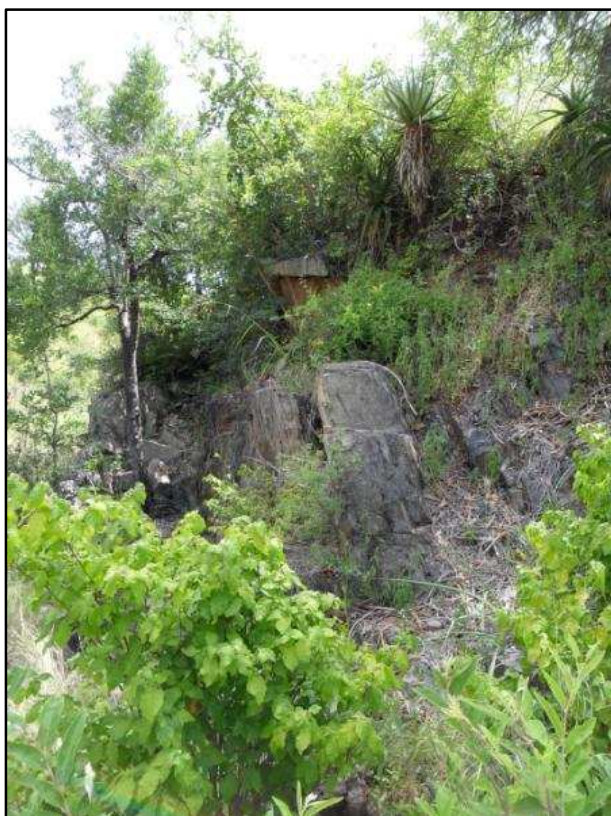
**PHOTOGRAPH 5: VIEW FROM TIMFENE RIVER UP SLOPE TOWARDS
SITE 2**

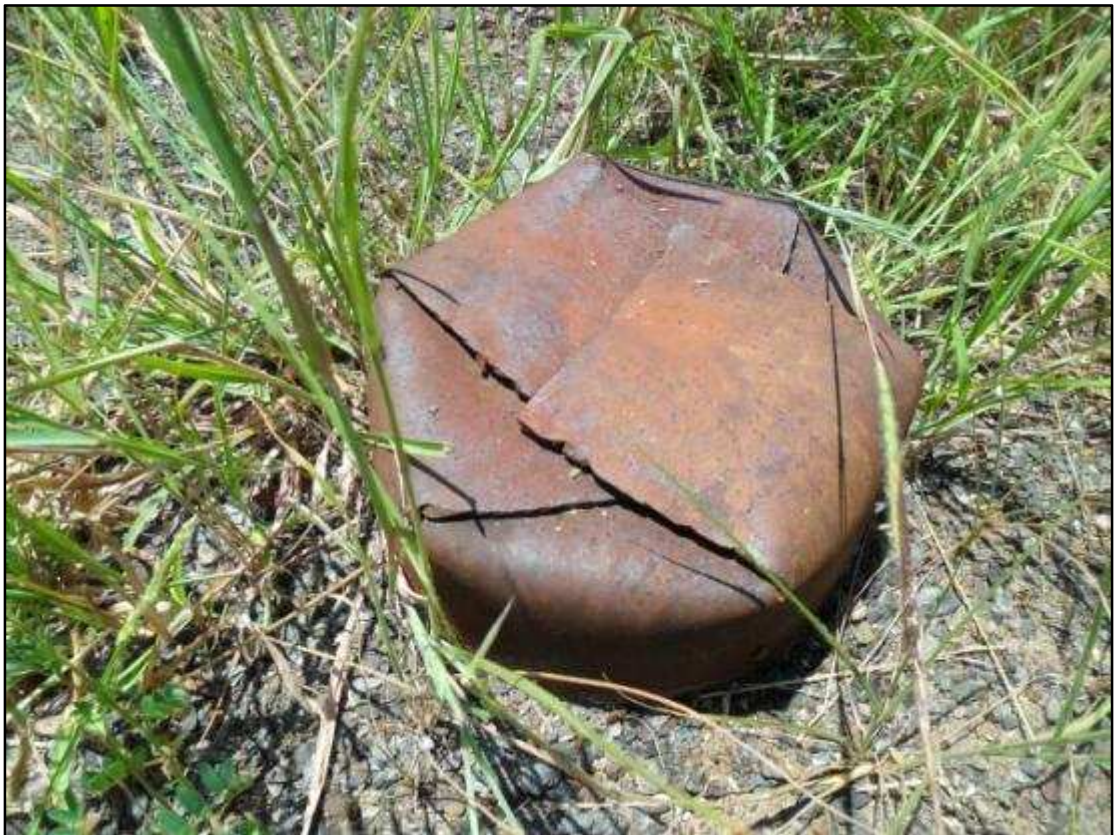
An existing borehole was observed on Site 4. The water level in the borehole was duly measured at 9.45 metres below natural ground level using a standard dip-meter.

PHOTOGRAPH 6: BOREHOLE ON SITE 4

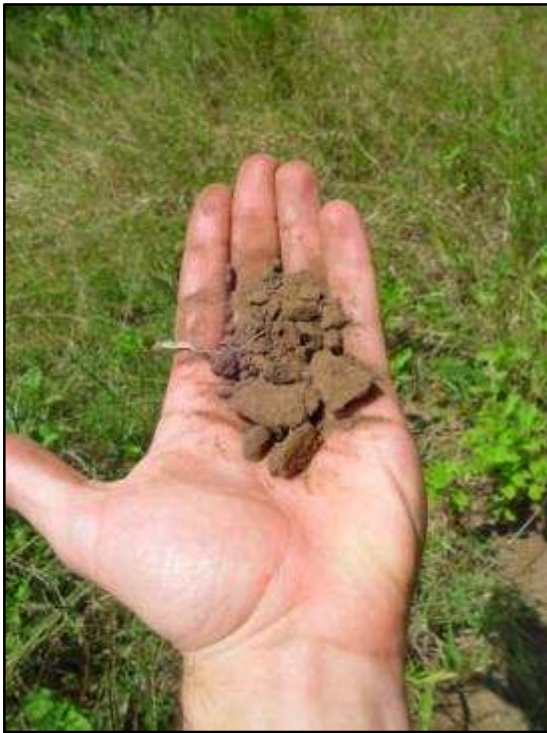
The main aquifers thought to exist include fractured and weathered rocks and the alluvium along the Crocodile River although the alluvium does not appear to be extensive (river channel is mainly rock outcrop). Suitable targets for abstraction boreholes would be the alluvium along the Crocodile River, the linear feature 800m west of the site and along the diabase dykes.

PHOTOGRAPH 7: ALLUVIAL MATERIAL

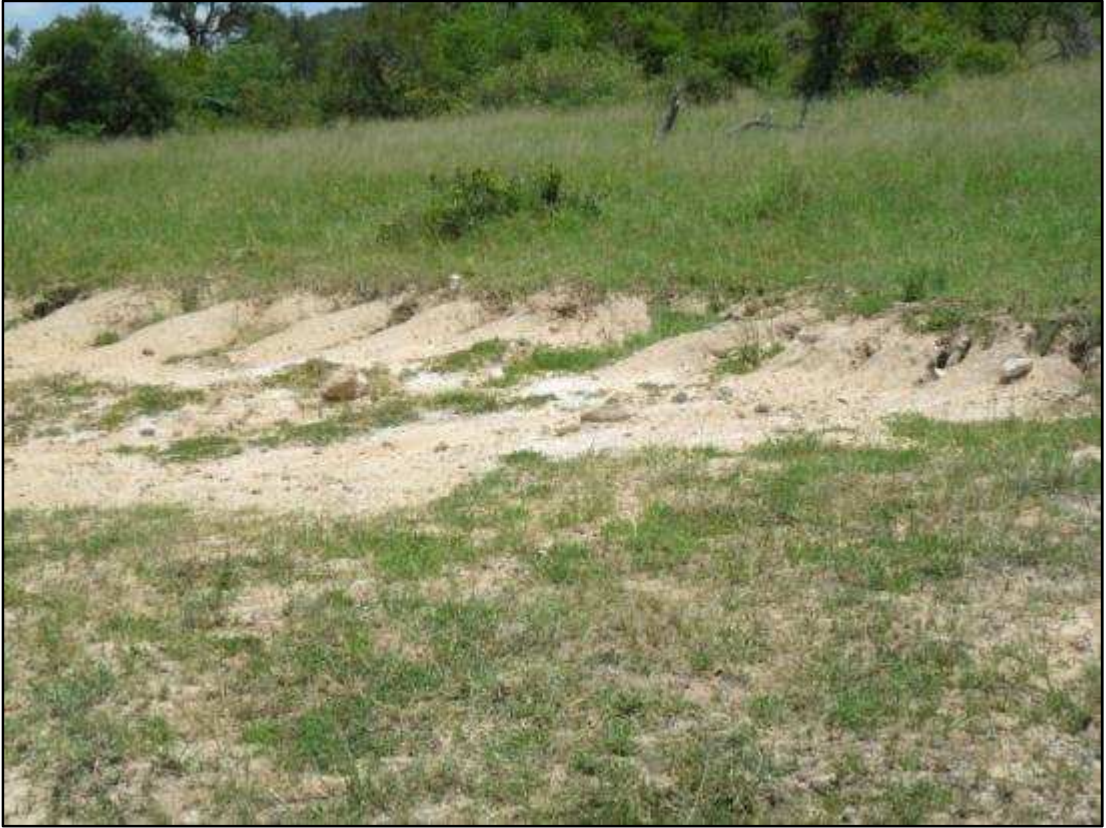
- Collapsible soils;
- Shallow seepage and/or perched water table;
- Compressible soils;
- Excavation difficulty;
- Soil with an intermediate to high erodability/dispersivity;
- Areas subject to flooding.

PHOTOGRAPH 8: INTERMEDIATE TO HIGHLY ERODIBLE/DISPERSIVE SOILS

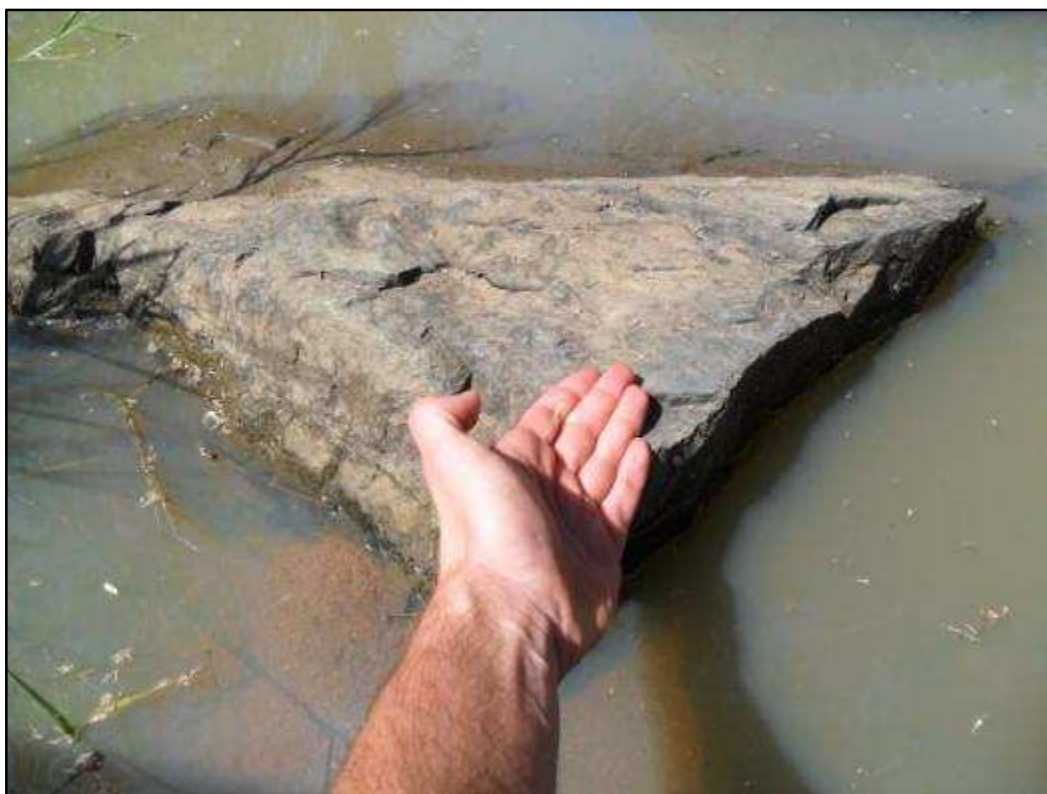
Komatiite and schist outcrops were identified in the Timfene River. The site itself however appears to be covered by surficial deposits of unknown depth.

PHOTOGRAPH 9: KOMATIITE OUTCROP IN TIMFENE RIVER

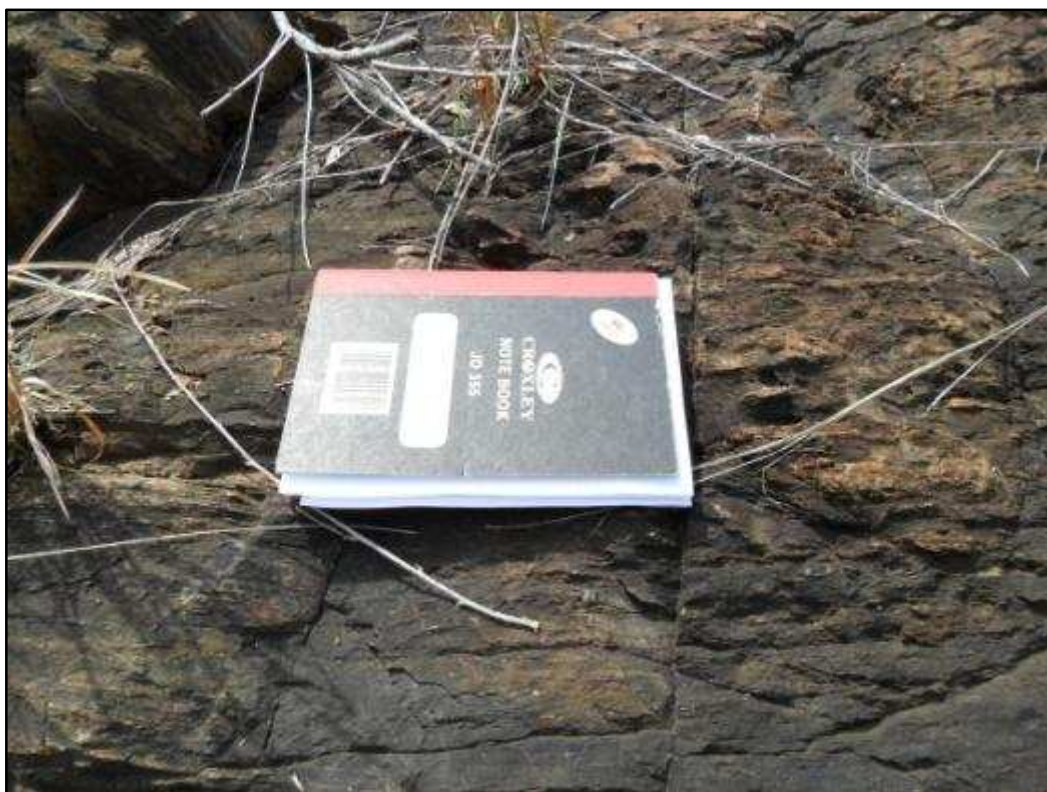
PHOTOGRAPH 9: MAFIC/ULTRAMAFIC ROCKS EXHIBITING SCHISTOSE STRUCTURE
